Wayfarer Modifications W 9657 Mk III

When I first obtained W9657 and brought it up to Thunder Bay and Lake Superior in late fall 03 it had the standard Abbott MkIII cottage boat outfitting. There were a lot of modifications needed and considered... the website WIT and various pictures were examined and I had numerous email questions and received a lot of good advice. Rigging for spinnaker usage became those hesitant first holes to be cut in mast and boat, but from there it got easier taking a drill to things. Many of the most needed rig alterations have since been undertaken but this year a few modifications addressed some other issues.

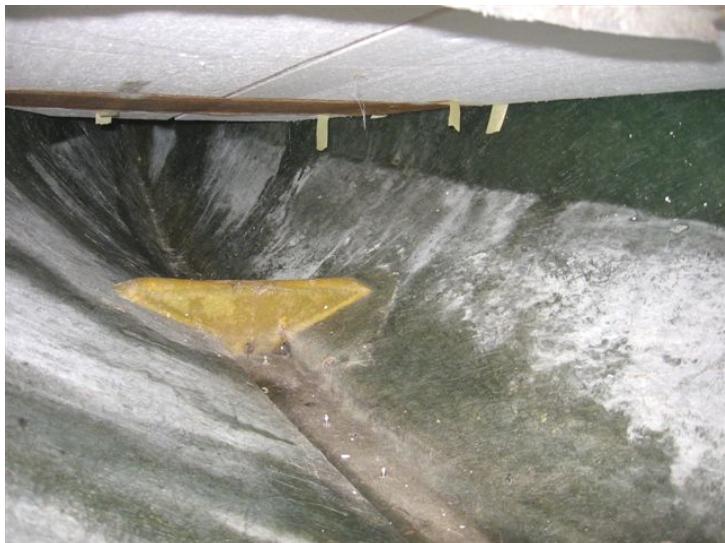
Provision of storage space in front buoyancy compartment.

Wayfarer MkIII bow floatation tank interior as found ... and a desire to utilize this forward space for cruising storage and shift weight out of the rear compartment as is possible with the other W versions. There is about 12" of height between the hull and fixed foam floatation. Discussions with the MkIII designer and manufacturer Abbott identified no reasons why the area couldn't be used and larger access holes placed through the bulkhead.

For access two 6"dia watertight inspection ports were installed in the forward bulkhead to replace the original single 4"dia inspection port. I hoped to use 8"dia ports but it seemed the bump-out for the seat support might obstruct this size. 6"dia doesn't sound like a big change but it certainly now allows smaller items (spare rope, tarp, beer, stove fuel bottle, etc.,) to be put into and retrieved from the bow tank. And although I didn't care by this point it is still in compliance with that puzzling Class Rule 21.3 listing the MkIII maximum size as (5" +/- 1¼") i.e. 6¼" max.
