BROTHER TN360 TONER CARTRIDGE

REMANUFACTURING THE BROTHER HL-2170W SERIES/TN360 TONER CARTRIDGE

By Mike Josiah and the Technical Staff at UniNet

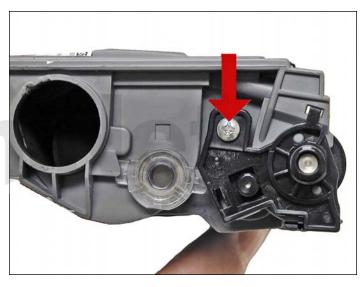
2. On the non gear side of the developer roller, remove the screw.

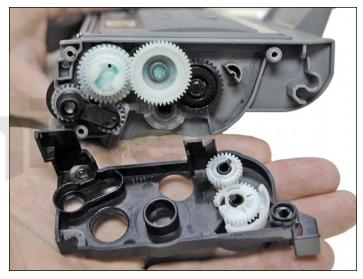
5. The reset gears are attached to the cover plate. These gears reset the printer when a new cartridge is installed.

New starter cartridges do not have these gears.

New replacement gears are available, and are required for remanufacturing these cartridges.

There is a set of reset gears that reset the printer each time a new toner cartridge is installed. Previous Brother cartridges have used a reset gear before, but this is the first time a set of gears has been used. The starter cartridges that come with new printers do not have these gears. Both the TN330 and the TN360 cartridges use different reset gears sets. The TN330 gears, in addition to being a different color from the TN-360, have a shorter gear train. That is how the machine knows if there is a standard or high-yield cartridge installed. New rest gears (at the time of this writing) are being developed.

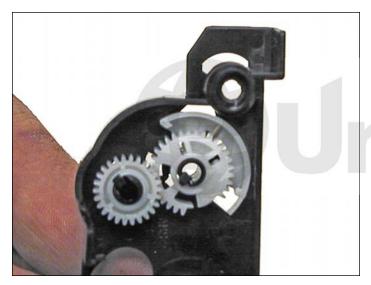
6. Remove the black plastic spacer from the developer roller shaft.

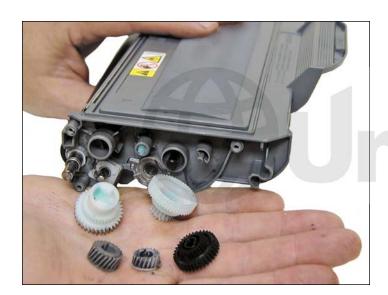
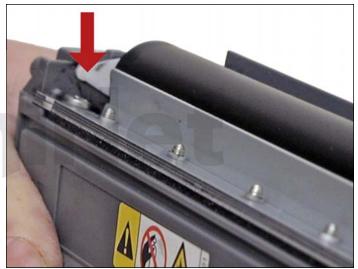
9. On the gear side of the developer roller, press in on the locking tab and rotate the developer roller lock up.

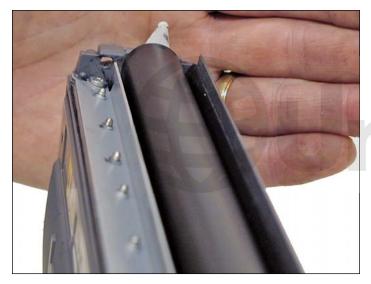
10. Remove the developer roller. Vacuum the doctor blade and foam feed roller clean. Until new blades are available, we do not recommend that the doctor blade be removed or the developer roller felt seals disturbed. The doctor blade can be easily cleaned by blowing the excess toner off, and wiping down with a lint free cloth. Be very careful not to leave any lint behind.

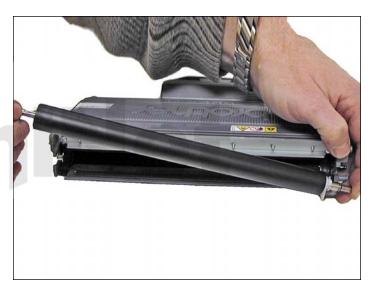
11. Inspect the magnetic roller felts. If they are compressed, (shiny) rough them up with a small screwdriver. Clean the developer roller with a lint free cloth. Do not use any chemicals other than a dedicated cleaner for Brother rollers to clean the roller. A dry clean cloth will work fine.

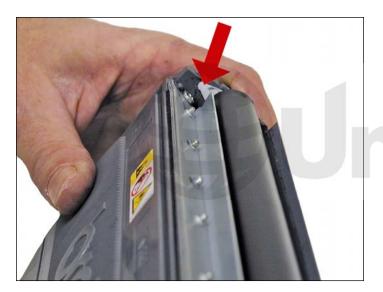
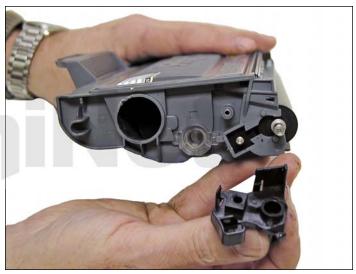
13. Install the small outside end plate and screw on the non-gear side.

Make sure the clear plastic plug for the optical sensor is locked in the proper position.

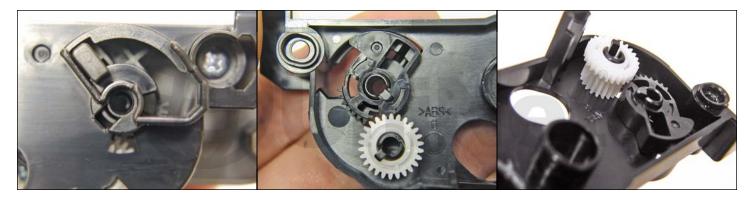
TN330.

Depending on the cartridge you have, set the two reset gears as shown:

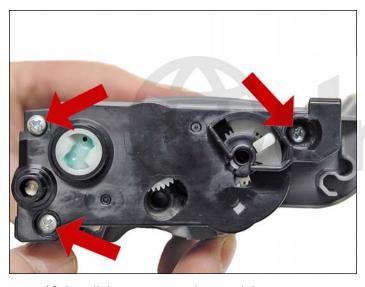
16. Install the gear cover plate, and three screws.

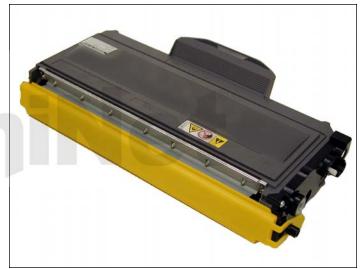
19. Install the developer roller cover.

Wipe the cartridge down to remove any remaining toner dust.
